AFWAL-TR-85-3125

AIRCRAFT TRANSPARENCY TEST METHODOLOGY

Final Technical Report for Period June 1984 - September 1985

FLIGHT DYNAMICS LABORATORY
AIR FORCE WRIGHT AERONAUTICAL LABORATORIES
AIR FORCE SYSTEMS COMMAND
WRIGHT-PATTERSON AIR FORCE BASE, OHIO 45433

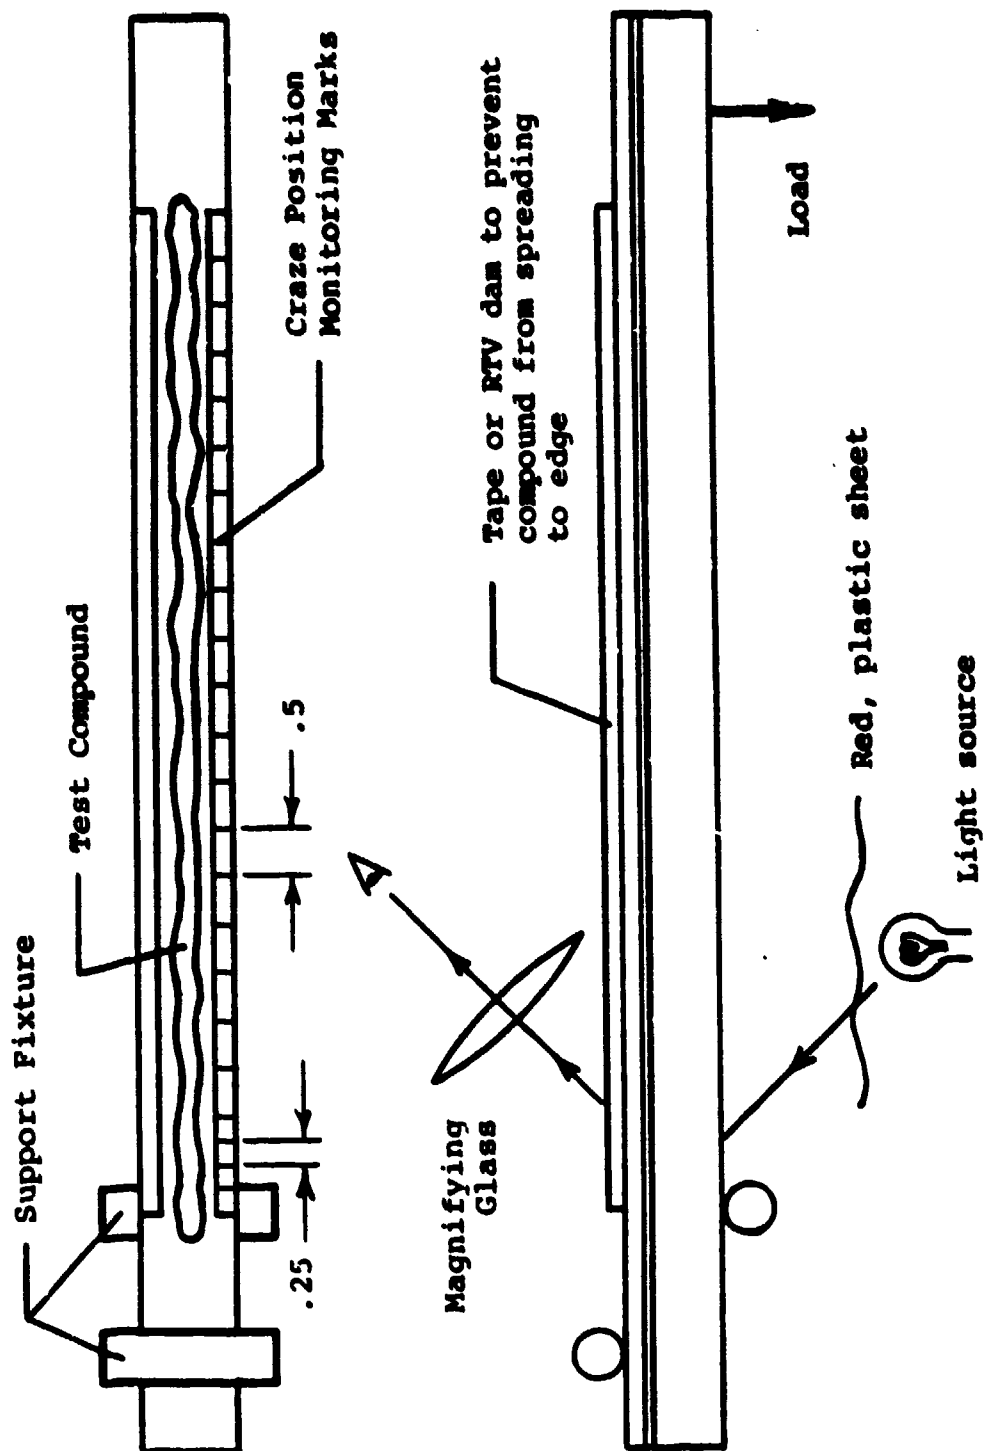
Figure 3.2. Setup for Modified Crazing Tests.

The hardware for the incremental stress craze test method (Figure 3.1) is very similar to that of the standard test method. The fixturing, including cantilever supports and load application gear, are identical. The extended specimen length facilitates correlation of craze location with discrete points (and thus values of bending stress) along the beam. These points are marked at one-quarter and one-half inch intervals as shown in Figure 3.2. Both laminated and monolithic specimens were tested.

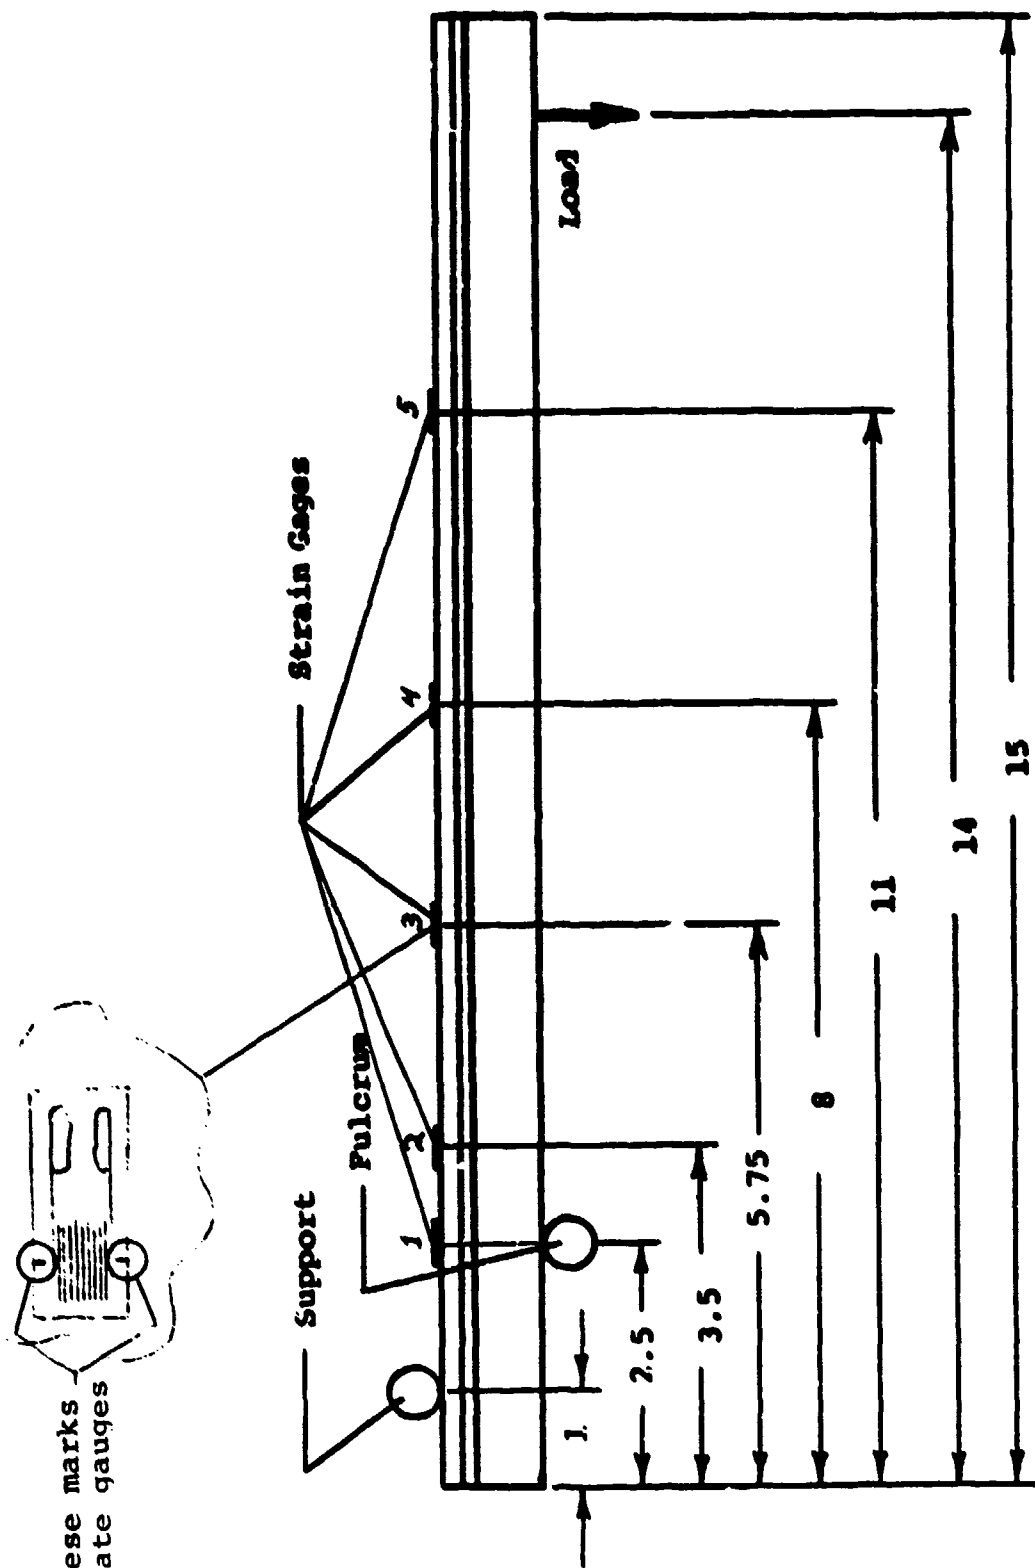
NOTE: All dimensions in inches.

Figure 3.3. Setup for Stress Calibration of Beam.

Calibration beams were loaded to determine the bending stress distribution over the beam length so that crazing locations could be matched with stress values. This distribution could not be computed using elementary beam theory for laminated material since low-modulus interlayers cause plane sections normal to the specimen axis to warp severely under test load and for the monolithic specimens, because of the large scale deflections, the validity of small deflection theory was questionable.

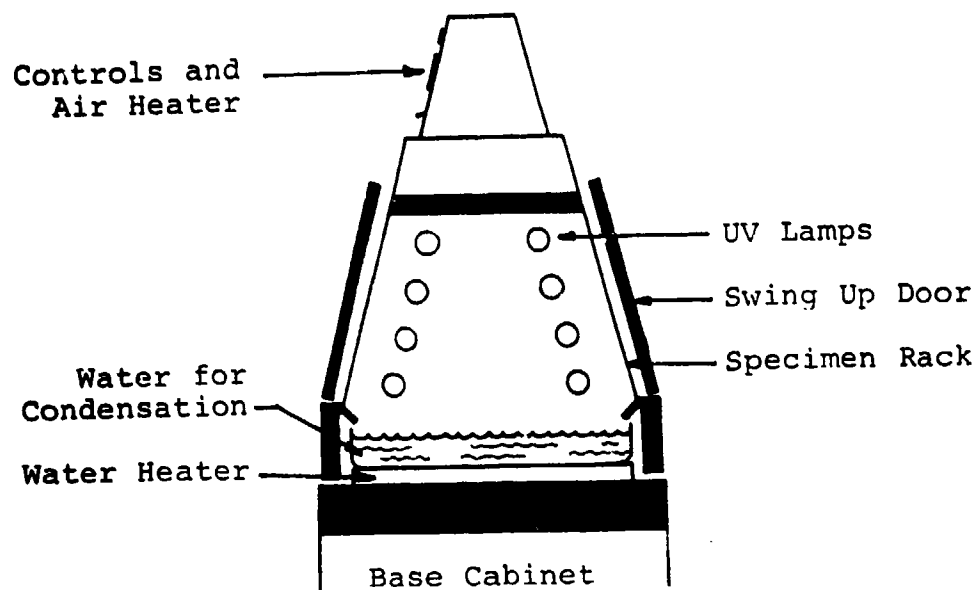
Schematic Cross Section

The Q.U.V. Accelerated Weathering Tester, manufactured by the Q-Panel Company, Cleveland, Ohio, and shown in Figure 3.4, combines the effects of the UV wavelengths of sunlight with heat and condensation to simulate accelerated weathering. Using the Q.U.V. tester with Q-Panel UVB-313 lamps, an operating temperature of 120°F, alternating cycles of 7 hours UV followed by 5 hours condensation, and based on a year of natural weathering being simulated by 168 hours run time, the specimens were conditioned for 504 hours or 3 equivalent

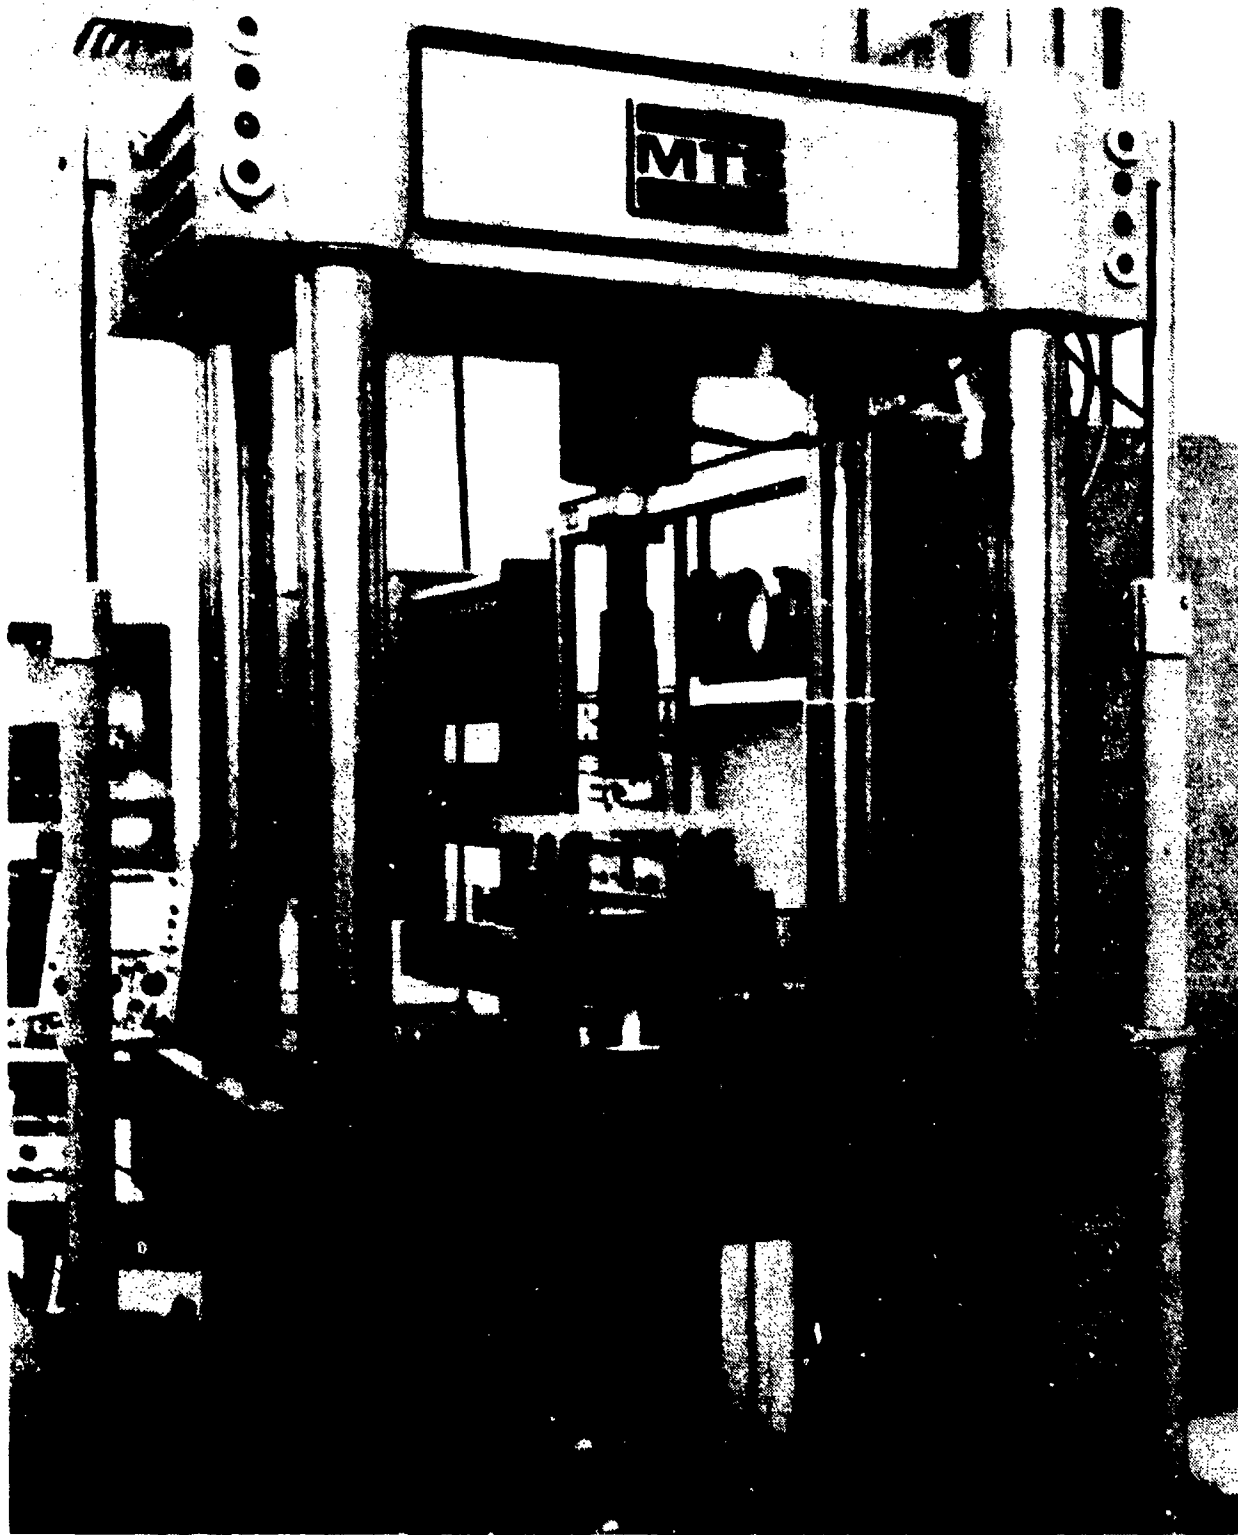
Figure 3.13. High Performance Electrohydraulic Closed Loop Test System.

load frame, appropriate transducers, an electronic feedback controller operating the actuator through an electrically controlled hydraulic servovalve, and suitable data gathering, storage, and recording instrumentation. It is a system of matched components manufactured by MTS Systems Corporation, Minneapolis, Minnesota. A mounting fixture was used to provide three-point simply-supported loading to the center of each beam specimen; the contact radius of each loading support being $3/8$ inch (reference: Figure 3.14). The span between supports was $6t$ with an overhang of $4t$ at each end, where t equals as-received thickness. The specimen was centered in the fixture with the test surface down, producing tension in the test surface under investigation. The two outer supports are part of the loading yoke below the specimen. This yoke is positioned above the vertically mounted actuator, and is attached to the top of the ram; the yoke moving upward to load the specimen. Ram position is measured by an LVDT (Linear Variable Differential Transformer), with this signal being sent as the feedback signal to the analog electronic feedback controller for the actuator; the command signal for the controller being generated by a selectable function generator. Displacement rate was controlled to be 2,000 inches/minute. Peak displacement was set at a selected value of 3.00 inches. The center loading support remained stationary during testing. The upper part of the center support is attached to the stationary load frame. Both load and displacement were set at zero when the specimen just touched the loading fixture. The calibrated output signals of both the LVDT and the load cell were captured in a dual channel digital transient waveform recorder and then played back on an X-Y recorder to document load versus displacement for each high-rate MTS beam test specimen.

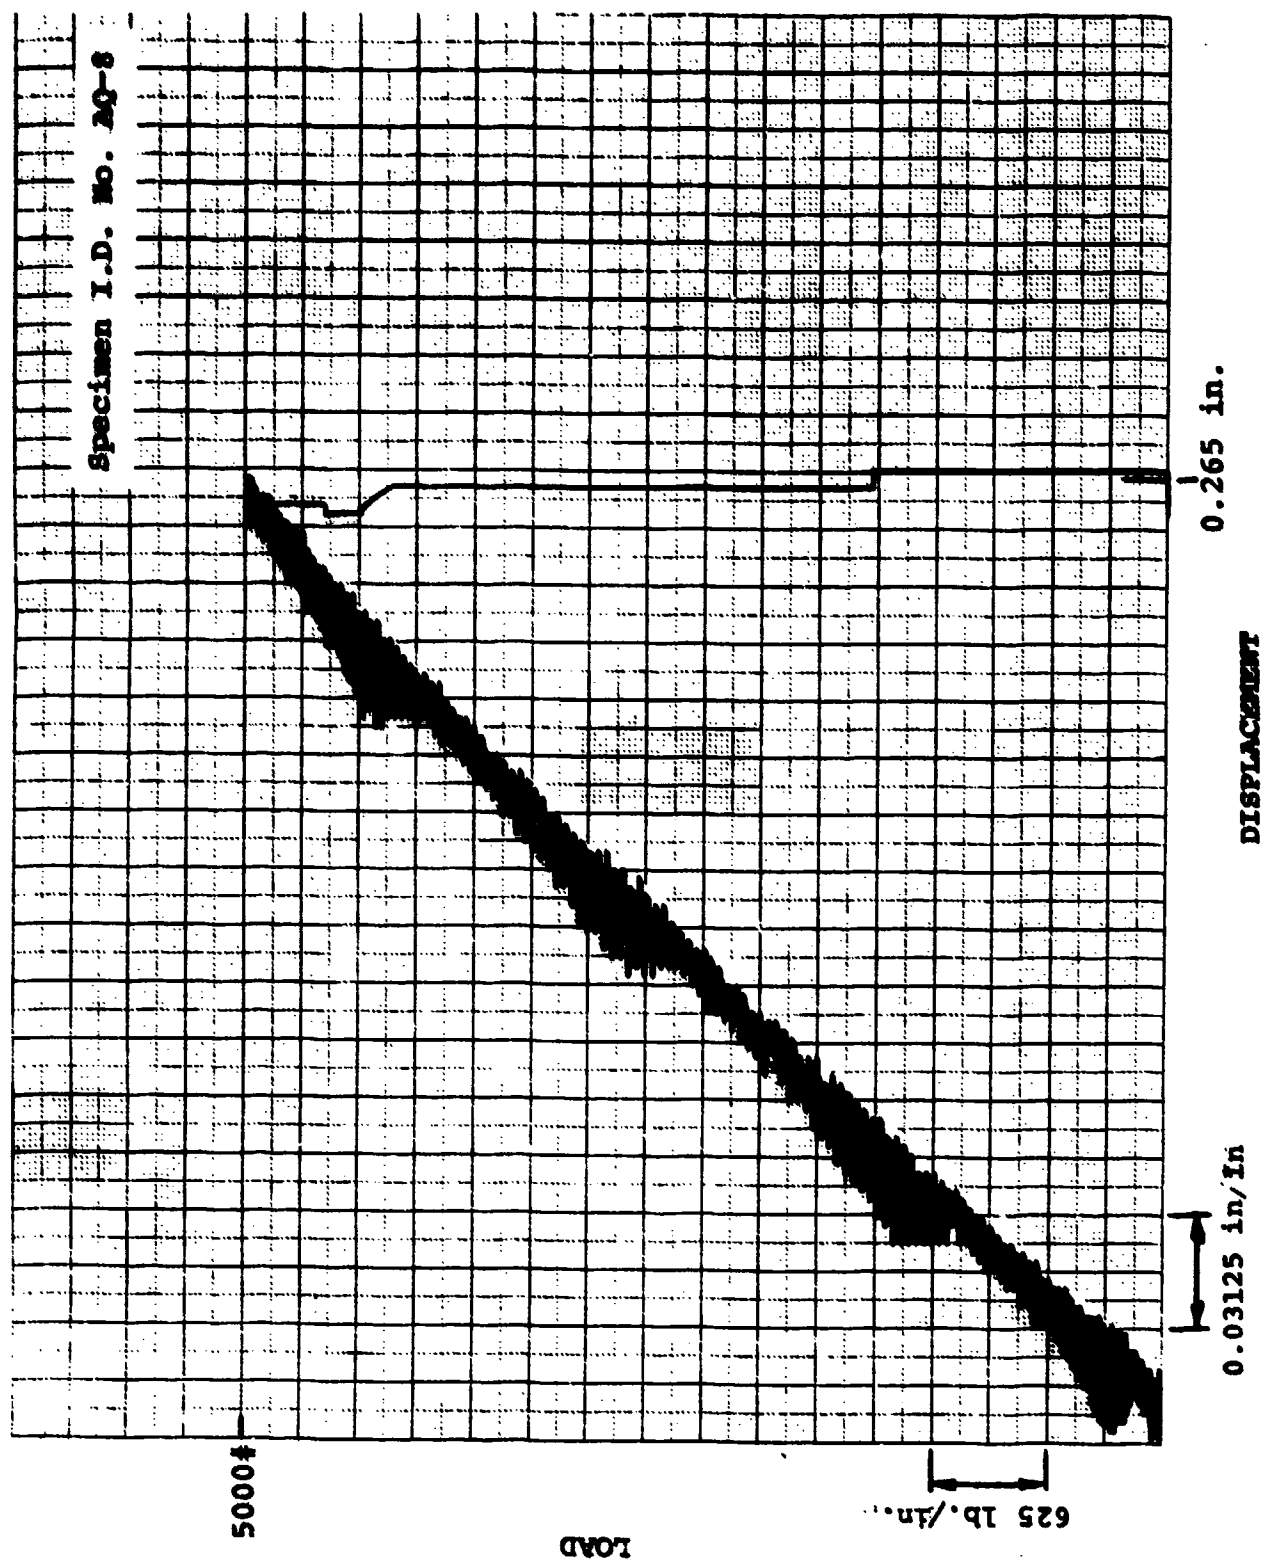
Figure 3.16. Typical Load vs. Displacement Plot, MTS Beam, F-15 Monolithic Stretched Acrylic Windshield.

Table 3.4 presents the MTS impact data generated for both baseline (unexposed) and environmentally conditioned beams tested at 2,000 inches per minute. Figures 3.16 through 3.20 show typical load versus displacement curves for each of the transparency designs.

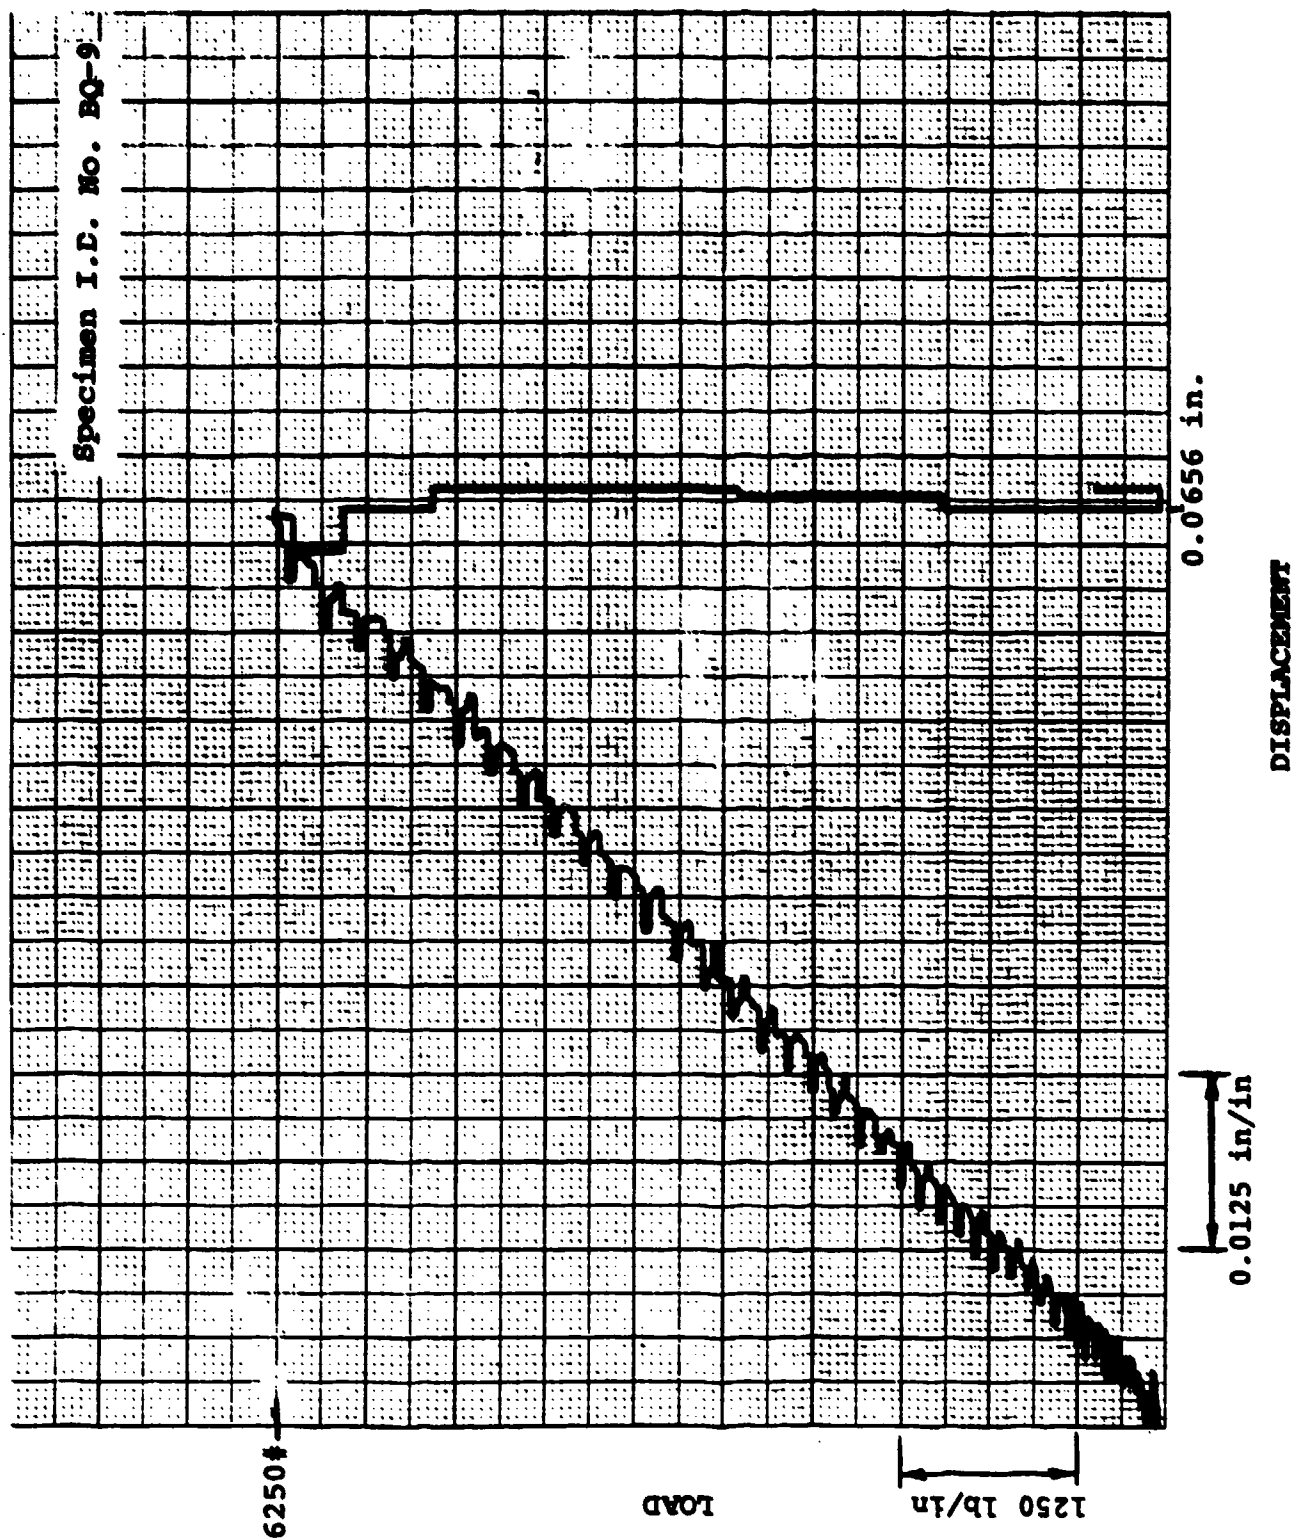
Figure 3.17. Typical Load vs. Displacement Plot, MTS Beam, F-15 Monolithic Stretched Acrylic Canopy.

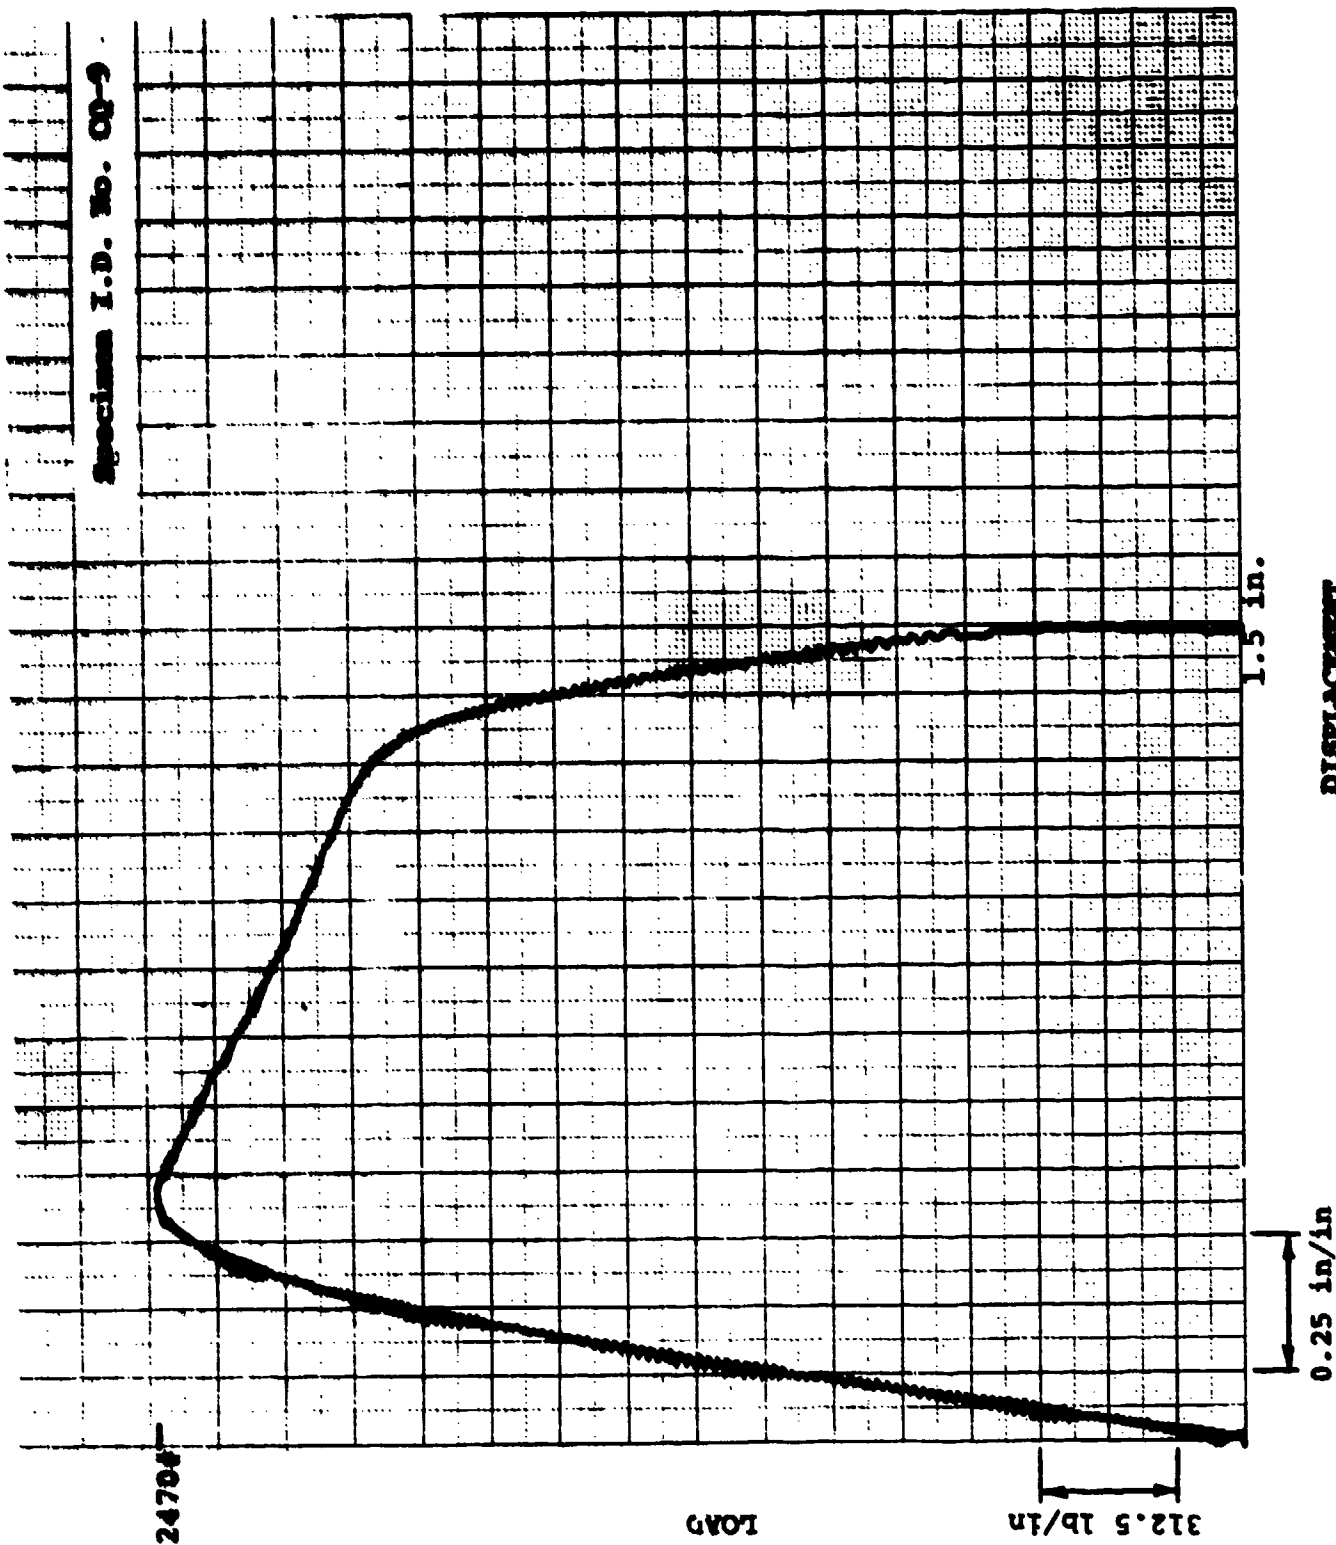
Figure 3.18. Typical Load vs. Displacement Plot, MRS Beam, P-16A Coated Monolithic Polycarbonate Canopy.

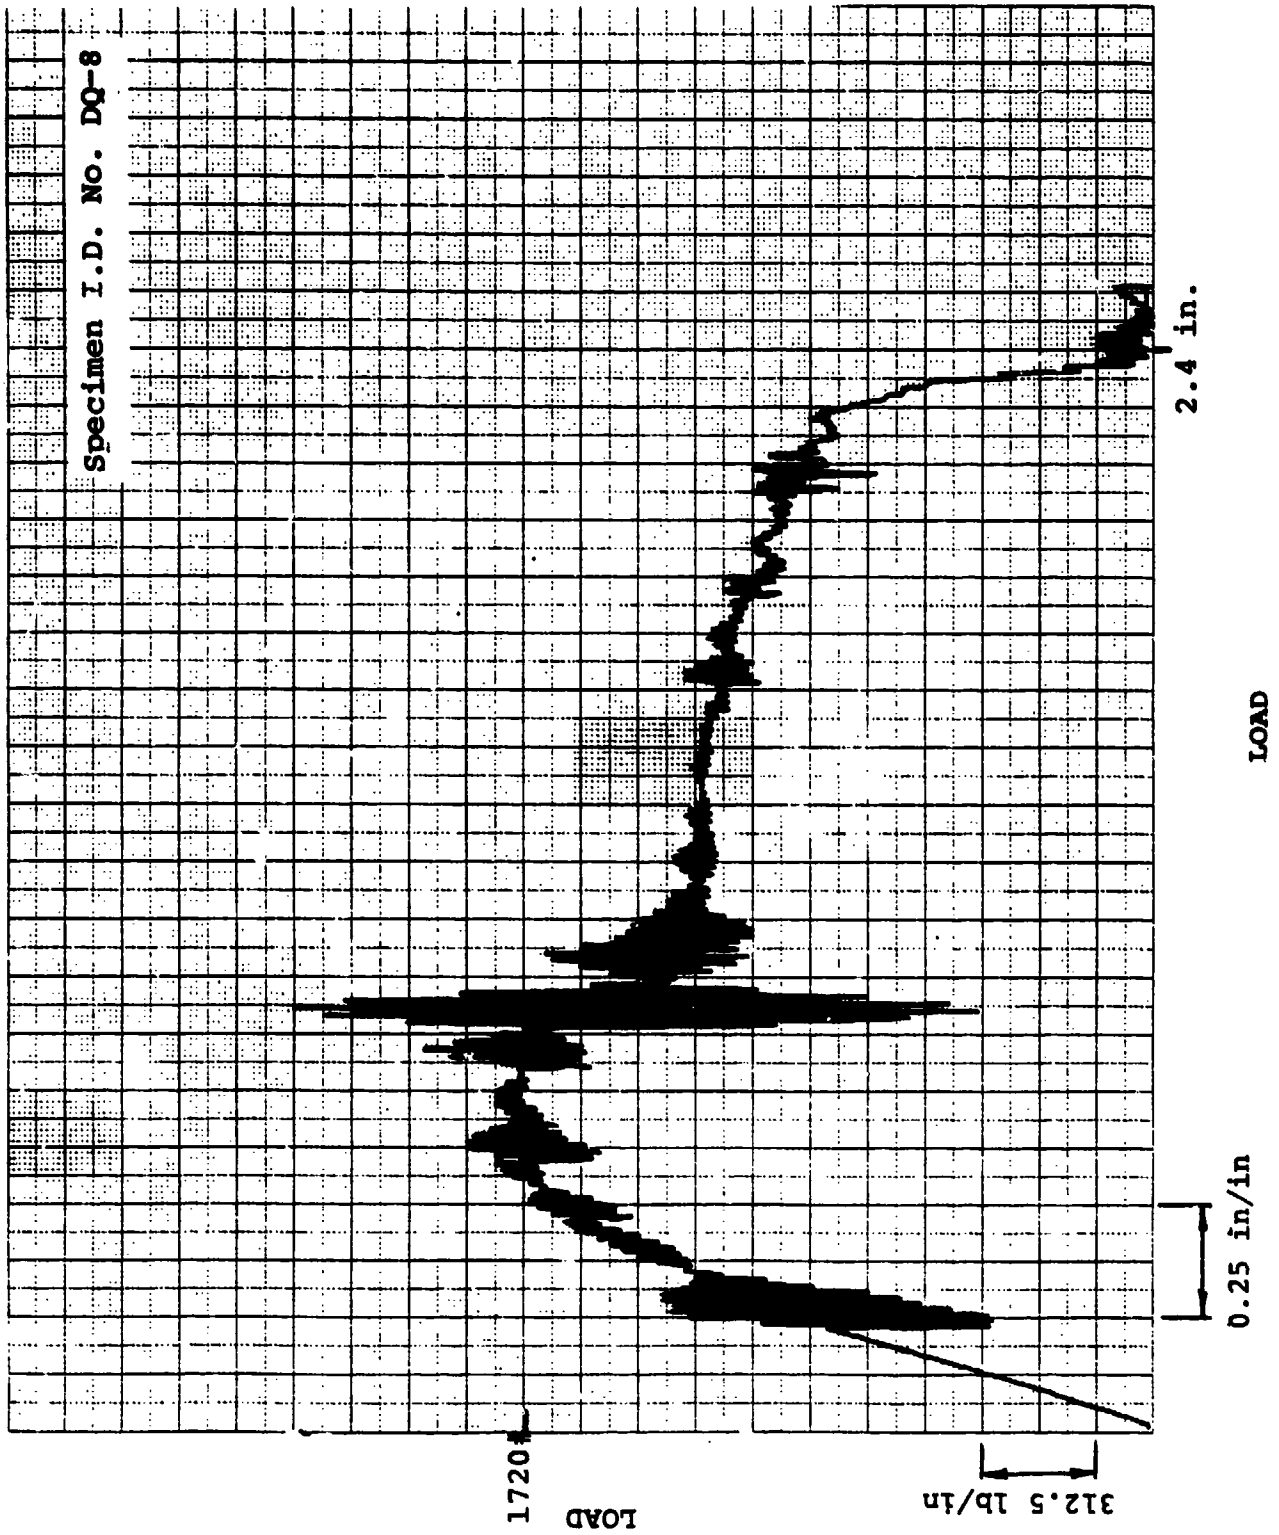
Figure 3.19. Typical Load vs. Displacement Plot, MTS Beam, F-16A Laminated Canopy.

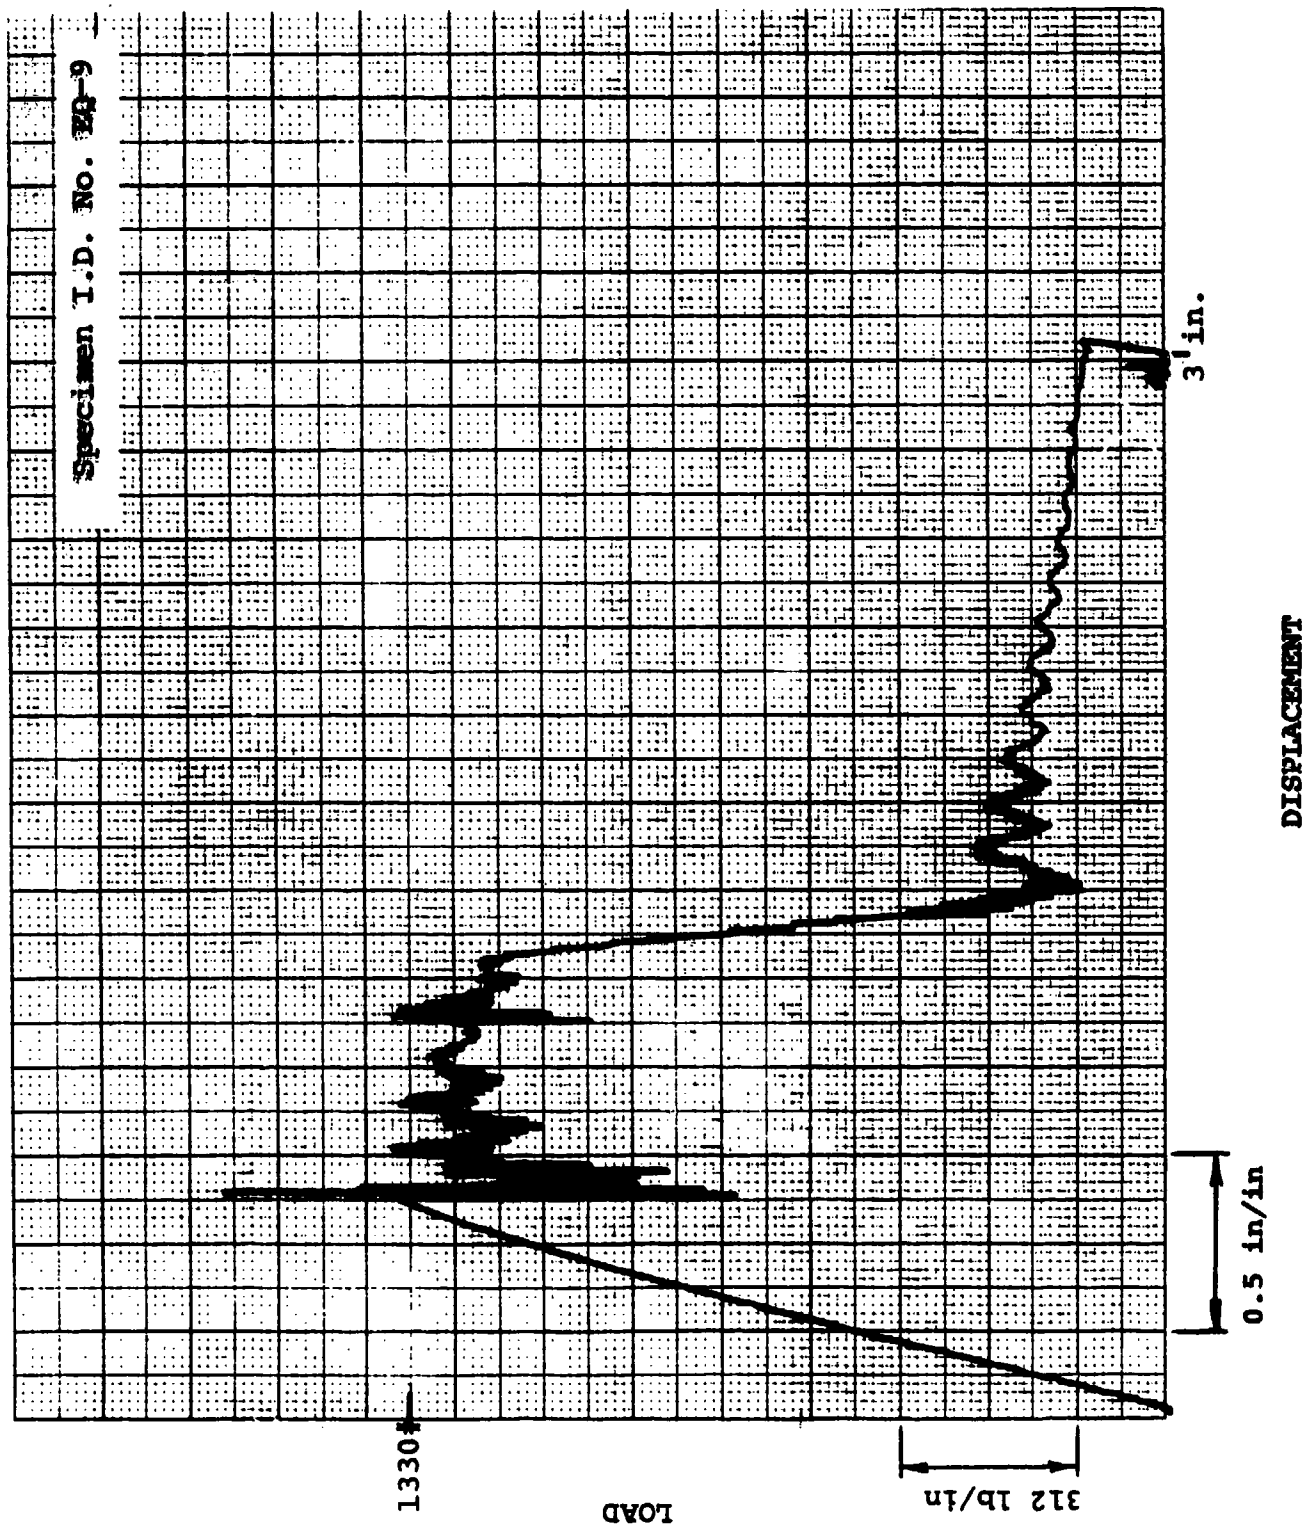
Figure 3.20. Typical Load vs. Displacement Plot, MTS Beam, F-111 Laminated ADBIRT Windshield.

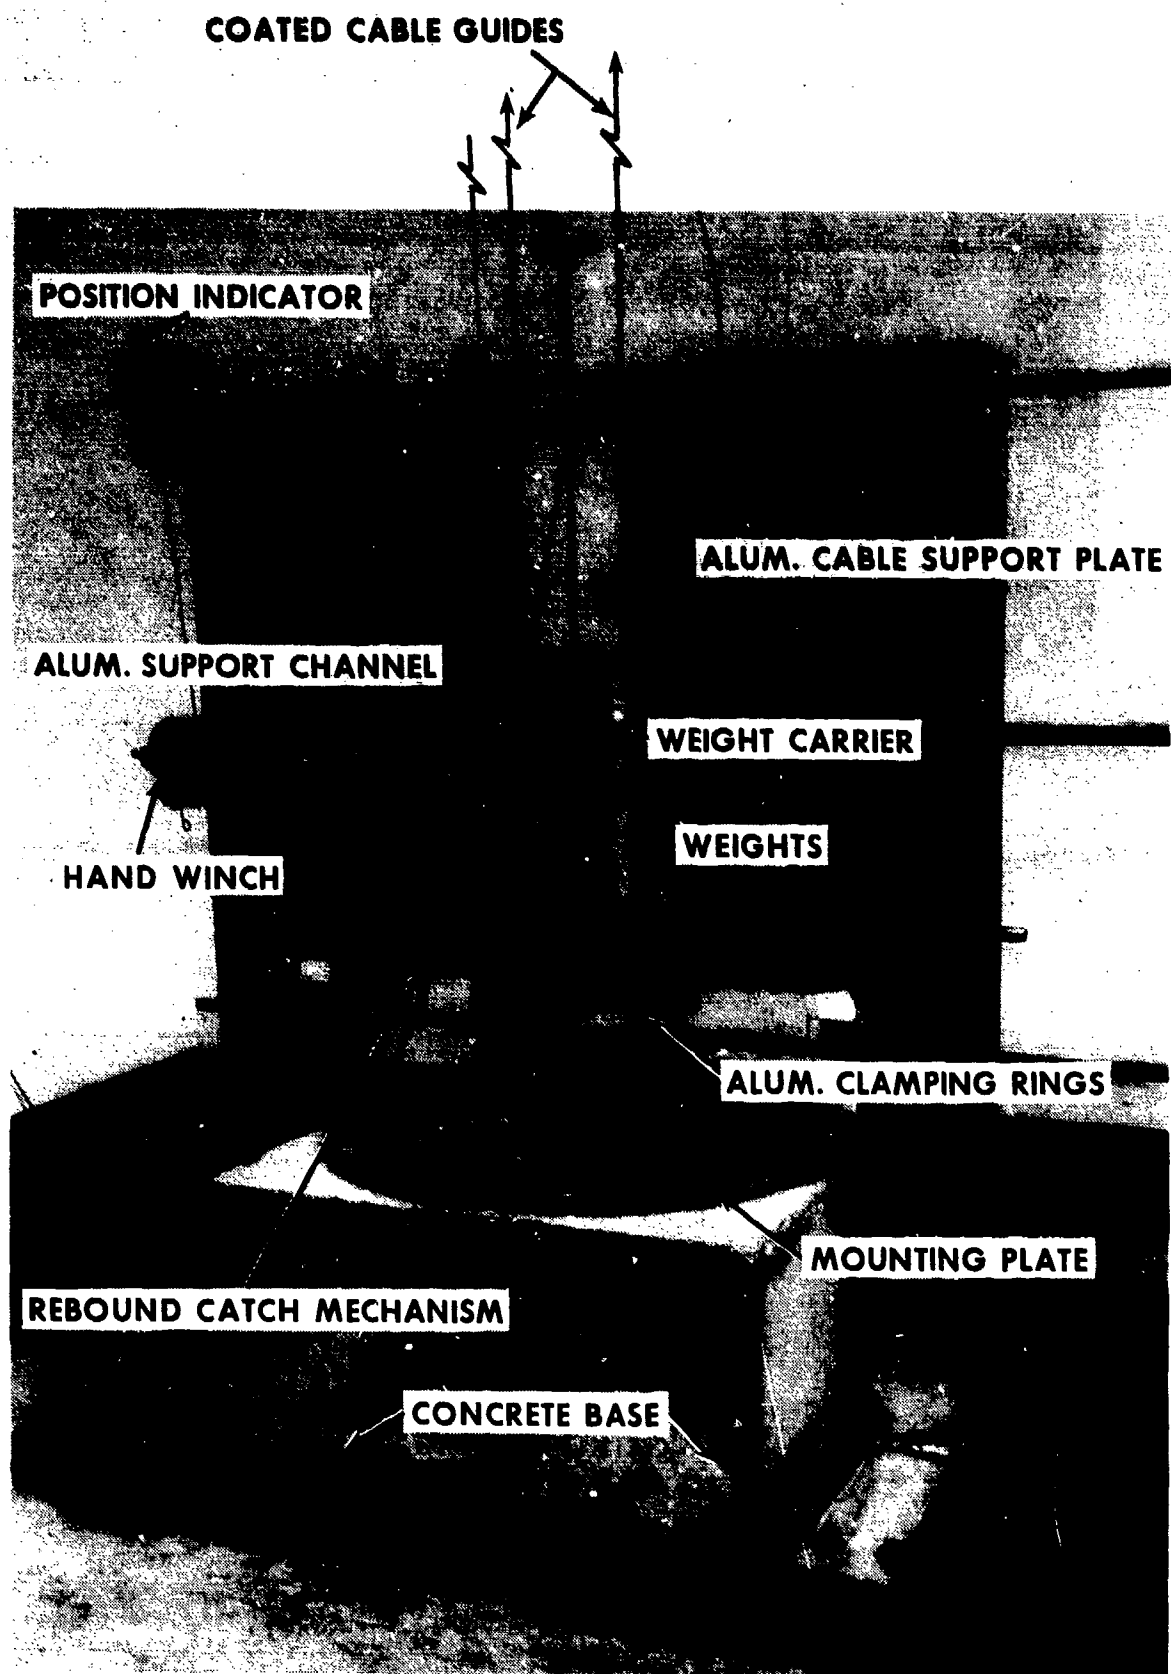
Figure 3.25. UDRI Falling Weight Impact Test Apparatus.

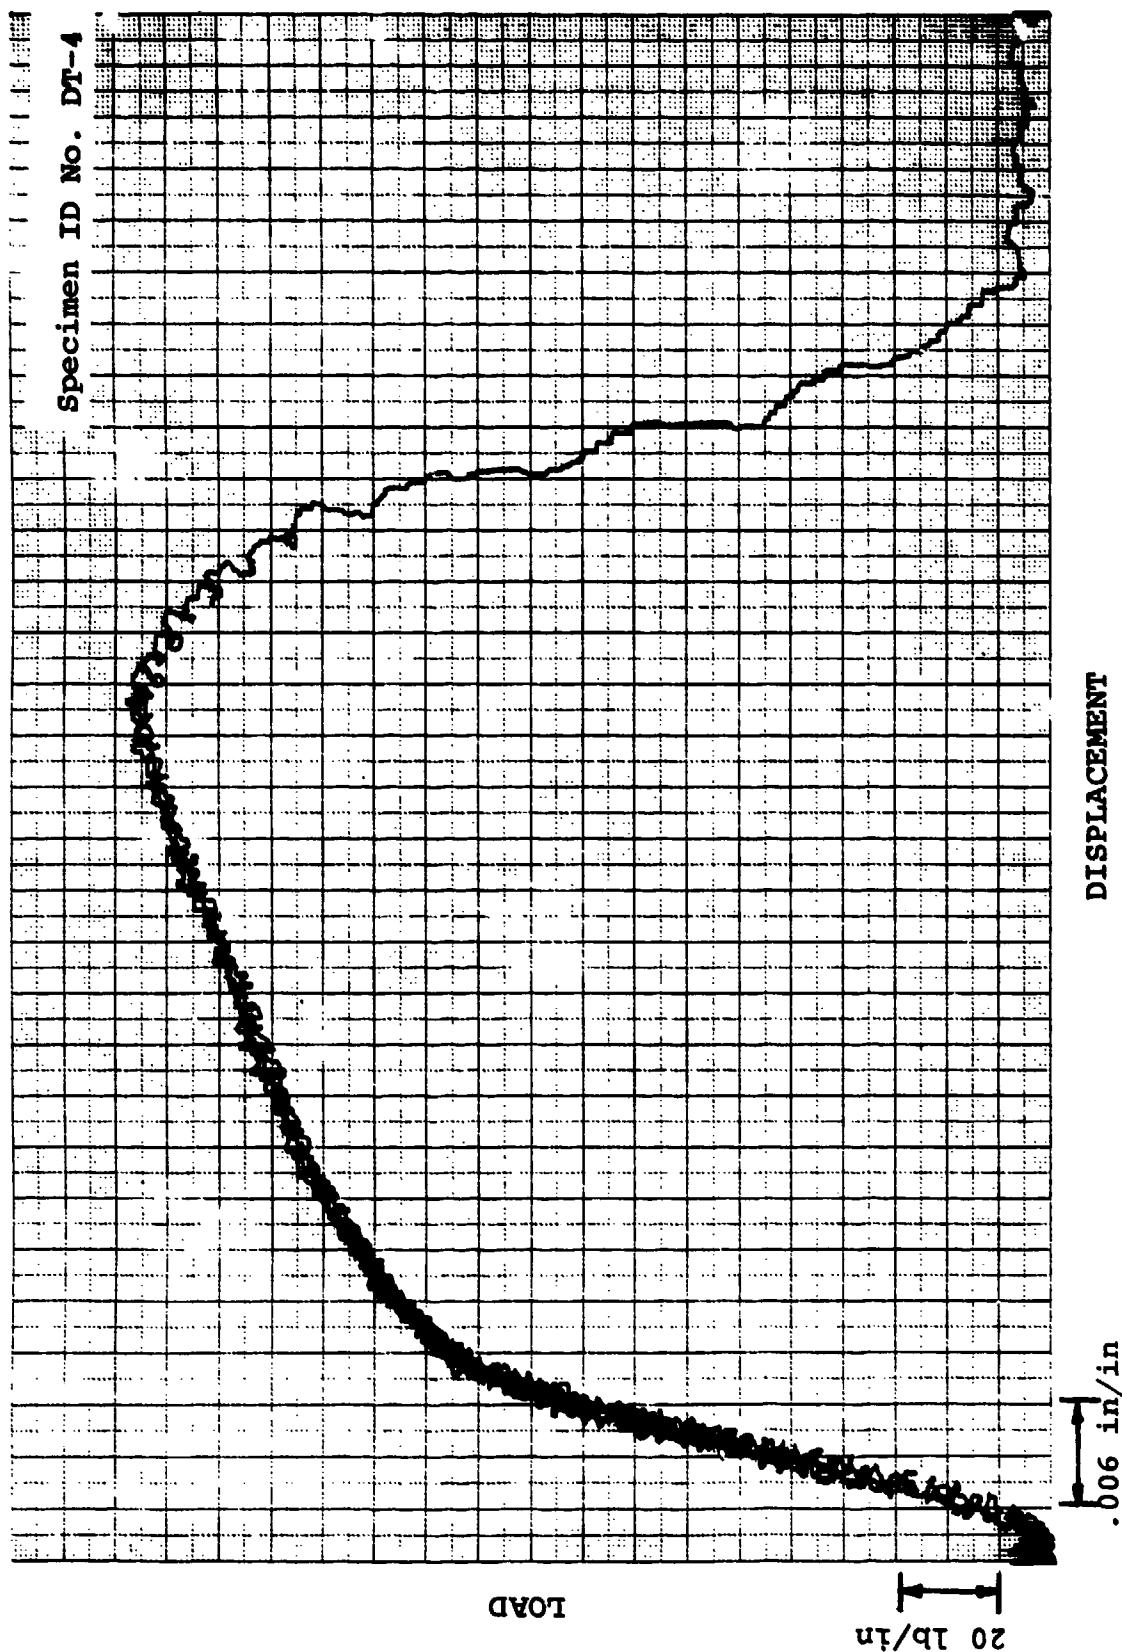
Figure 3.31. Typical Load vs. Displacement Plot, Flatwise Tension, F-16A Laminated Canopy.

Failures occurred in the silicone interlayer for both the F-16 and F-111 laminated transparencies; an adhesive failure at an average ultimate tensile stress of 392 psi for the F-16 and a cohesive failure at an average ultimate

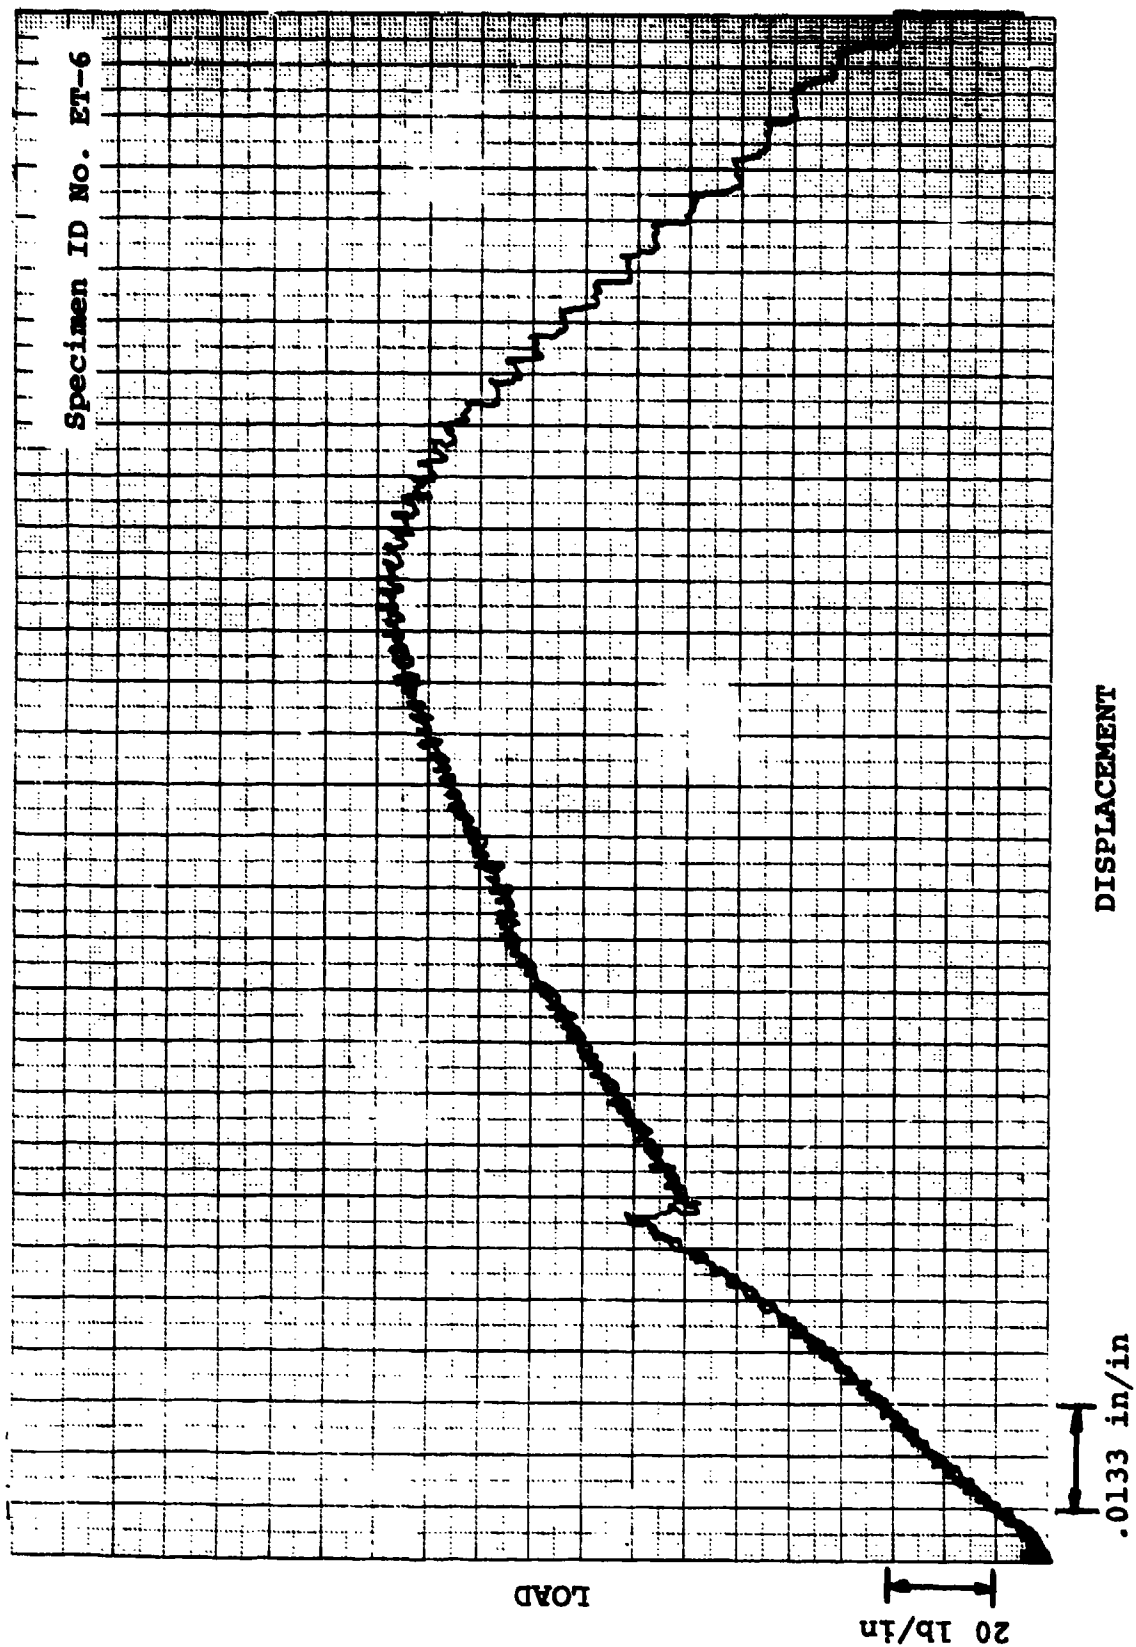
Figure 3.32. Typical Load vs. Displacement Plot, Flatwise Tension, F-111 Laminated ADBIT Windshield.

tensile stress of 307 psi for the F-111. Compared to previous test results from the Reference 3 program conducted on flat sheet material, these values appear low; previous data showing 570 psi ultimate for the F-16. However, the Reference 3 program used a loading rate of 10,000 lbs/sec compared to 100 lbs/sec used for this testing program. The silicone is strain-rate sensitive, and at a higher strain rate can withstand a higher peak load. Both of these transparencies are manufactured by Sierracin; it is not obvious why the interlayer failures were different--adhesive at a higher strength for the F-16 laminated transparency and cohesive at a lower strength for the F-111 laminated transparency. Typical failed specimens are shown in Figure 3.33.

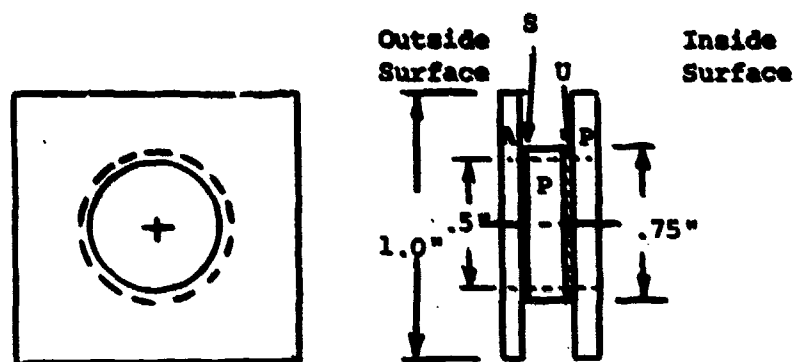
▨ - Tested Interlayer
(not to scale)

A = Acrylic
P = Polycarbonate
S = Silicone
U = Urethane

Figure 3.34. Modified Torsion Shear Specimen.
